THESIS

A STUDY OF THE MICROSTRUCTURAL BASIS FOR THE
STRENGTH AND TOUGHNESS PROPERTIES OF
AS-QUENCHED AND QUENCHED AND TEMPERED HIGH
COPPER HSLA-100 STEEL

Harvey Allen Winters

DECEMBER 1991

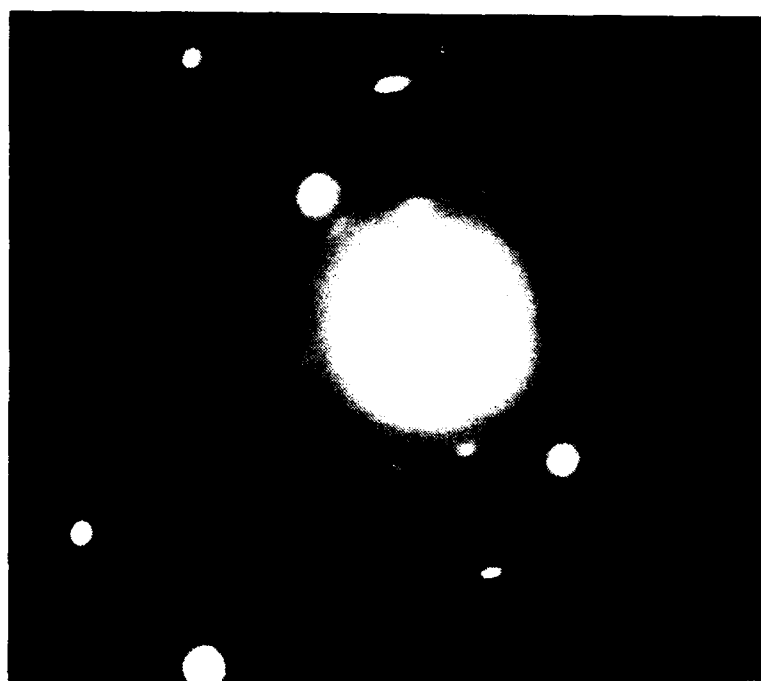
Figure 7 Selected Area Diffraction Pattern (SADP) Showing Presence of ϵ Copper Precipitates.

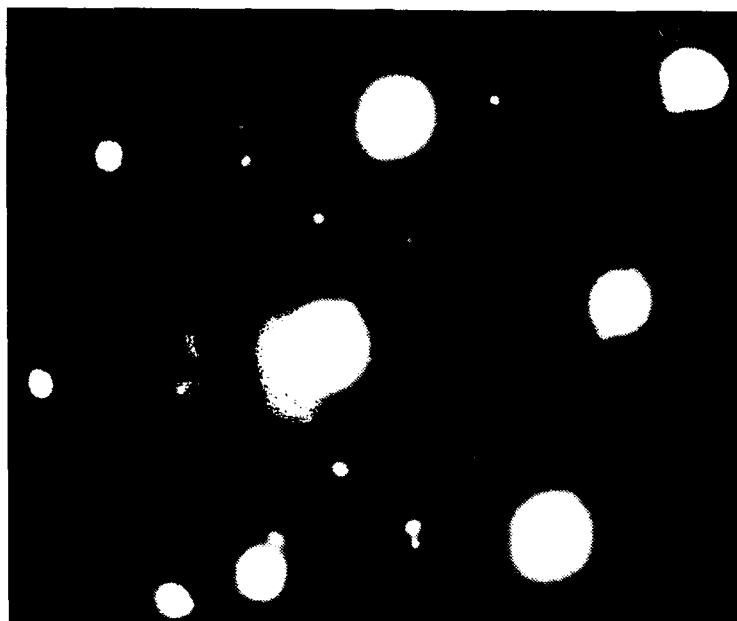
Figure 24 **Diffraction Pattern Showing a [012]**
Crystallographic Zone Axis. (Note the Faint Spots
Attributed to Fe_3C Precipitates)

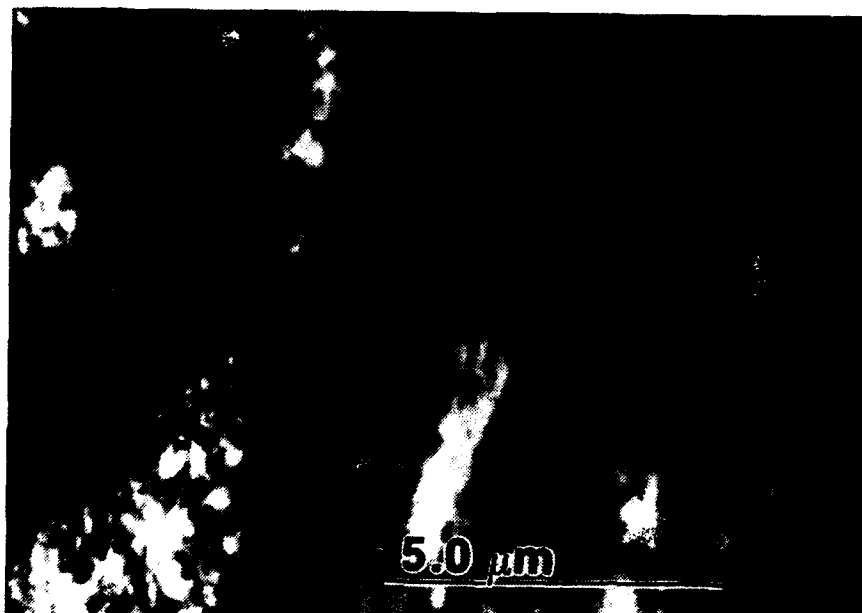
Figure 37 TEM Image Showing Wider Lath Widths of 621°C Aged High Copper HSLA-100 Steel

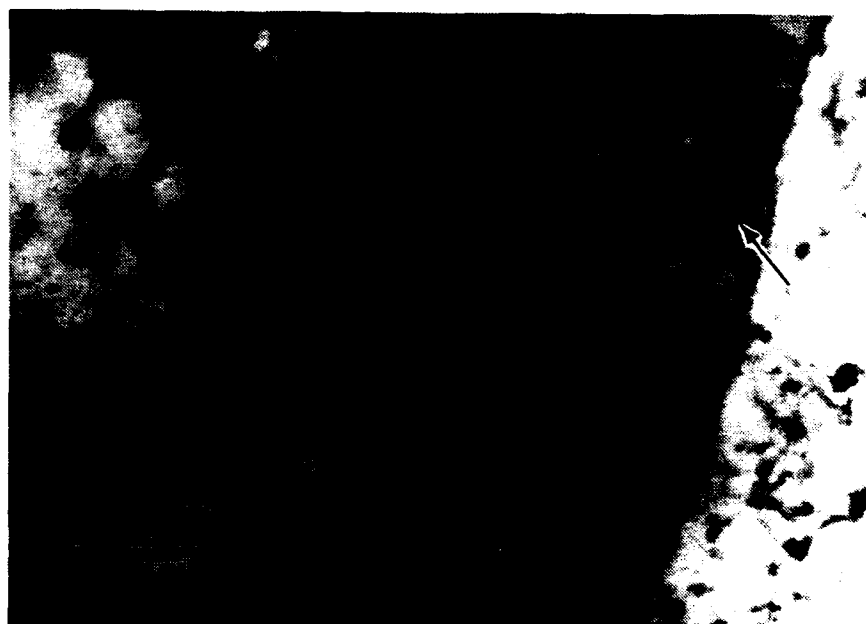
Figure 38 TEM Image Showing Incoherent FCC Copper Precipitates Decorating Dislocations and a Large Niobium Carbide or Carbonitride (arrowed)

type precipitate. These copper precipitates can be seen decorating dislocations and lath boundaries in Figure 38. Figure 39 also shows incoherent FCC precipitates. Figure 38 also shows a niobium carbide or carbonitride that has now precipitated in the overaged condition. These carbides are of the NbCN type and can be seen in Figures 40 and 41. The coherent FCC copper precipitates are also present in the SADP, Figure 41. This SADP is complex and contains patterns from temper carbides (most likely $(FeM)_3C$) and ϵ -copper precipitates.
